Project Profile

Innovative Roof Restoration for Stein Seal Warehouse

Kulpsville, Pennsylvania

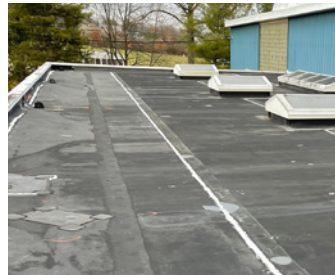
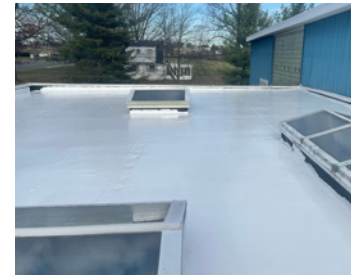
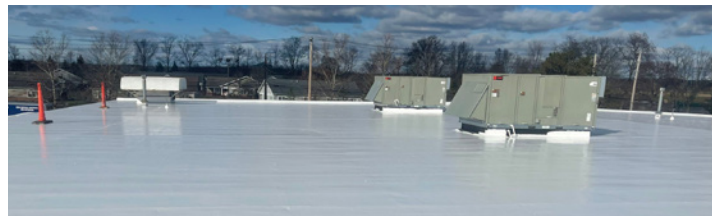
- **Roof Longevity:** The silicone restoration system prolonged the life of the facility's existing Hypalon membrane roof.
- **Leak Prevention:** All existing leaks were successfully addressed.
- **Cost Efficiency:** Offered 4 times the cost savings compared to a full replacement.*
- **Energy Conservation:** Reduced energy costs by up to 50% and prevented site downtime.**
- **Waste Reduction:** The restoration method produced significantly less waste than a full replacement.

Stein Seal turned to Henry, a leading provider of high performance roof restoration systems. Henry, in turn, recommended a local partner, REMTEK Services, Inc. Under the guidance of Chris Nuhfer, RAMTEK Services Contractor, Stein Seal chose to install Pro-Grade® 988 Silicone White Roof Coating.

Pro-Grade 988 Silicone White Roof Coating is a solvent-free, one-component, moisture-curing silicone rubber roof coating system that delivers long lasting reflectivity and energy savings. Its patented Dirt Pick-Up Resistance (DPUR) technology formula has a reputation for staying whiter and brighter longer than similar systems.
